FACILITY COMPLIANCE INSPECTION REPORT

Division of Waste Management Solid Waste Section

Waste Management Transfer Station, Ranlo Facility
 2712 Lowell Rd.
 Gastonia, NC 28054

Comprehensive compliance audit.

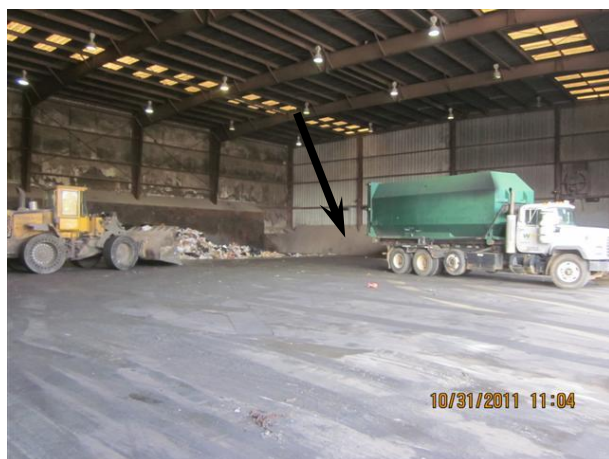
9. A "Contingency Plan for Managing Unauthorized Wastes" is maintained in the scale house.
10. Records of random waste screenings were reviewed. Wastes are typically screened two to three times a week.
11. The facility was actively accepting waste during the audit. (Photo #1)
12. No prohibited wastes were observed during the audit.
13. The tipping floor was very clean and well maintained. (Photo #1)

1. Looking across the tipping floor. The receiving bay is located along the right side of the facility. (Note the clean & well maintained tipping floor.)

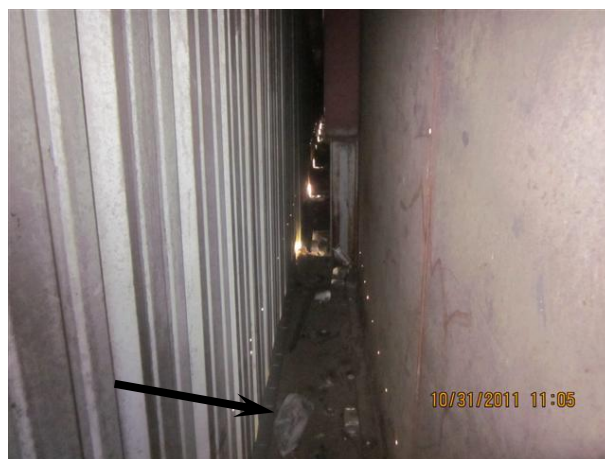
2. Looking behind the push wall on the left side of the transfer station. (Note the minor amounts of trash that must be removed.)

14. A small amount of trash was observed behind the interior push wall on the north side of the transfer station.
Please ensure that all waste is removed from behind the push walls, and properly disposed of, at the end of every operational day. (Photo #2)

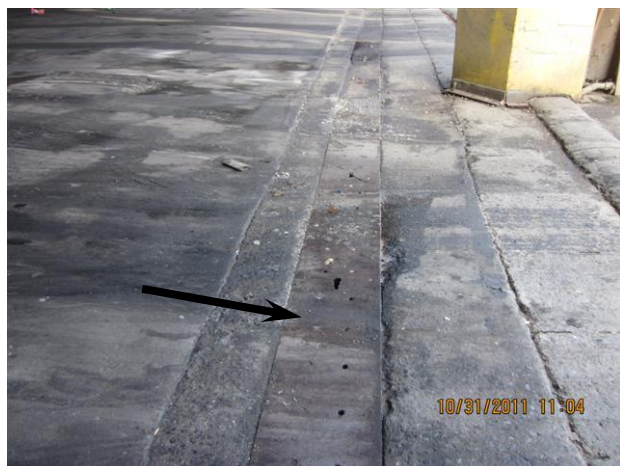
15. There was no evidence of any vectors (flies, rodents, insects or other vermin) in or around the transfer station.
16. Leachate and wash down water are collected in a trench drain across the entrance to the transfer station (Photo #3) and in two floor drains in the receiving bay (Photo #4). These drains feed into a 1,500-gallon underground storage tank (UST) located behind the station. This UST serves as a “grit chamber” to settle out any solids before the liquids flow into an adjacent underground oil-water separator (Photo #5). The outfall from the oil-water separator is direct piped to the Gastonia waste water treatment plant for final treatment and disposal. The “grit chamber” UST is pumped out approximately twice a year. Safety-Kleen Systems, Inc. last pumped out the UST approximately seven days ago.

3. Looking at the trench drain that runs across the entrance to the transfer station.

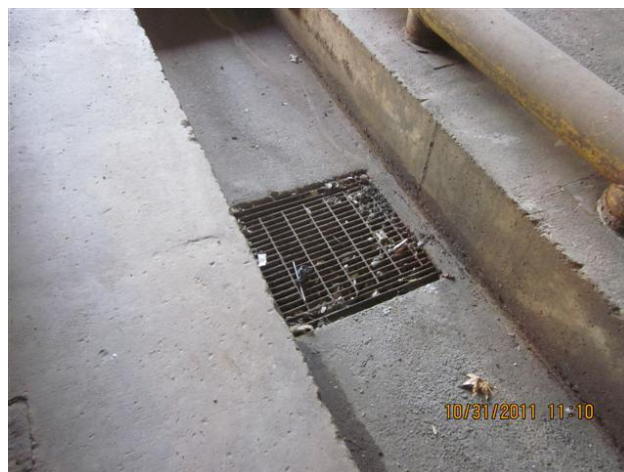
4. One of two floor drains in the receiving bay.

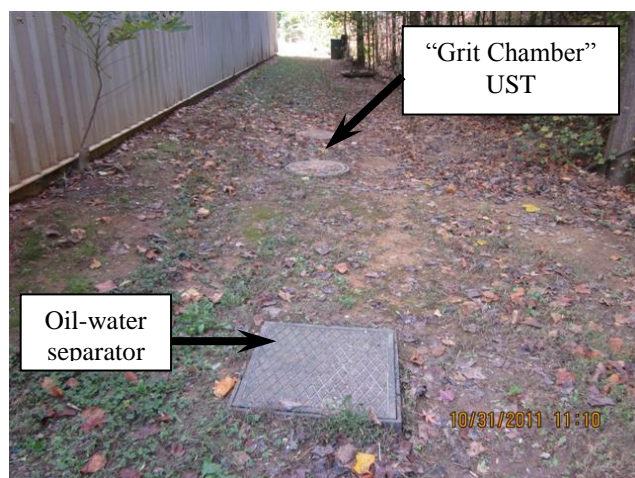
5. Looking at the access points to the “Grit Chamber” and the oil-water separator located behind the transfer station.

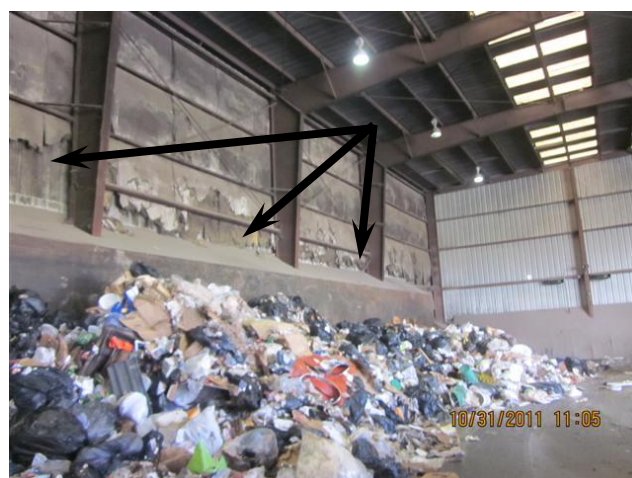
6. Looking at the back of the transfer station. Note the broken and loose insulation batting on the upper back wall.

17. The upper back wall of the transfer station has been lined with insulation batting to deaden the noise from the facility. This insulation is covered with soot and grime. Efforts to clean the upper back wall, has caused the insulation to become loose, broken and in some areas, missing (Photo #6). **The facility must develop and initiate procedures to ensure that the insulation is maintained in a clean and sanitary condition at all times.**
